Westinghouse Astronuclear Laboratory

WANL-TNR-224

NRX-A6 FINAL REPORT

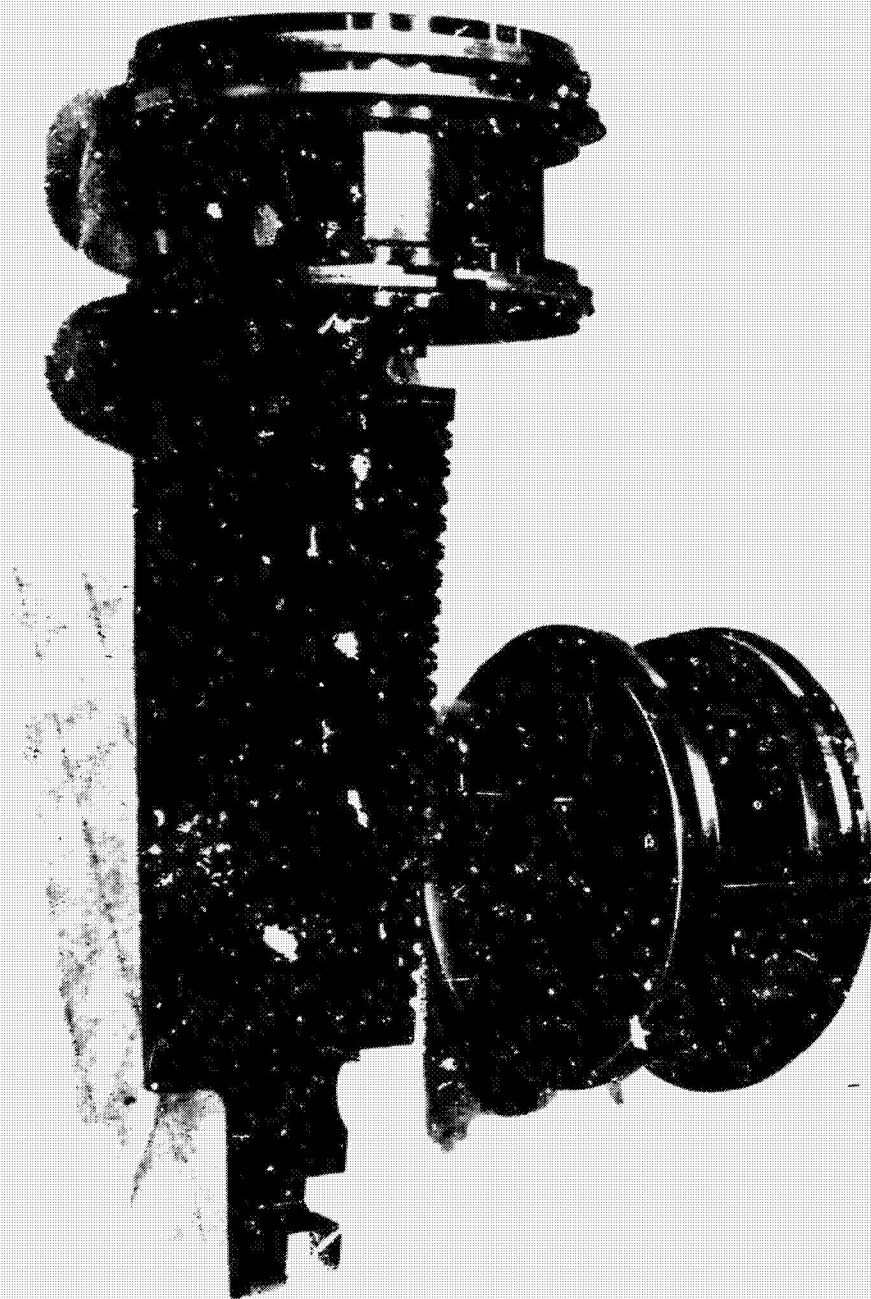
Figure 5-60. (U) NRX-A6 Side-By-Side Actuator Post Test Condition
(P₁ Piston and Rack Assembly, P₂ Piston and All Piston
Rings).
